Ignition unit of ROTAX engine 912 A

Revision 1

Subject: As known from experience, inadequate ground connection could arise between stator and ignition housing on the engine type 912 A.

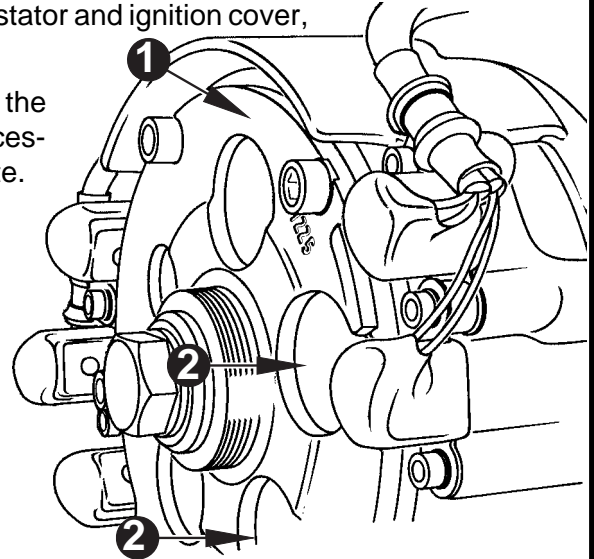
Reason: Isolated formation of corrosion between stator and ignition cover, respectively at attachment screws.

Disconnect battery. No need to withdraw magneto housing ① with magneto ring. Remove at least 2 of the 4 Allen screws ③ and lock washers for stator attachment via the openings ② in the magneto housing.

■ **ATTENTION:** Make absolutely sure that no foreign matter (lock washer or screws) will stick to the magneto ring.
