TBO for ROTAX Engine Series Type 912 A

Mandatory

- Subject:** Increase of TBO from 600h or 10 years to 1000h or 10 years of operation.
- Engines affected:** All engines of Series Type 912 A starting with engine no. 4,076.192 in accordance with Type Certificate TW 8/89.

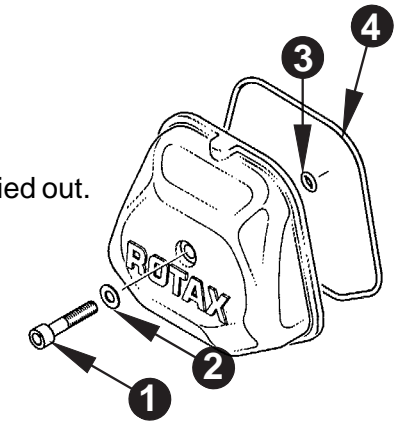
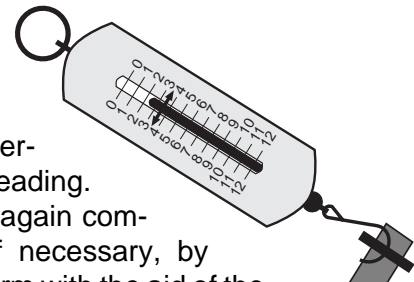
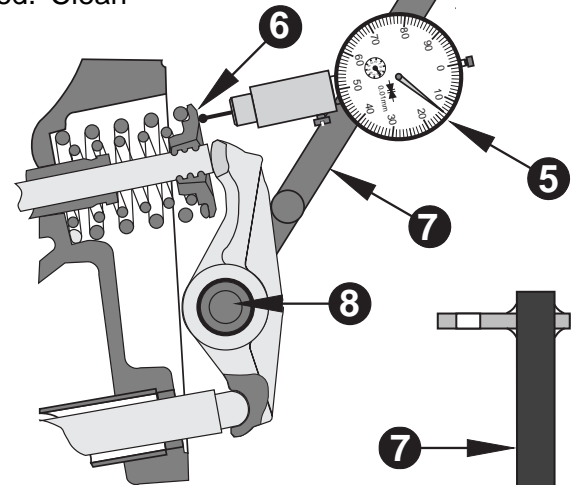
2) Check of valve spring tension:

Disconnect minus terminal of the battery. Remove Allen screw M6x30 **1** and washer **2** from valve cover and take off cover along with o-rings **3** and **4**. Set cylinder 1 to ignition T.D.C. Fit dial gauge **5** to indicate any movement of valve spring retainer **6**. Fit test lever **7** part no. 877 690 in hollow rocker arm shaft **8** and determine the spring tension on both valves by utilizing a spring balance. Read value on the balance, part no. 877 700, between 0,2 ÷ 0,3 mm (.008 ÷ .012 in.) indication on dial gauge.

◆ **NOTE:** Read at first try, with force steadily rising, otherwise action of hydraulic tappet will falsify reading. After a misreading wait until valve is closed again completely. Valve closing can be quickened if necessary, by applying pressure to push rod side of rocker arm with the aid of the test lever.

The value shown on the spring balance must not be below 35 N (8 lbf).

Valve springs with lower tension must be renewed. Clean sealing face, place both o-rings on valve cover and attach cover with Allen screw M6 x 30 and washer. Tightening torque 10 Nm (90 in lb).

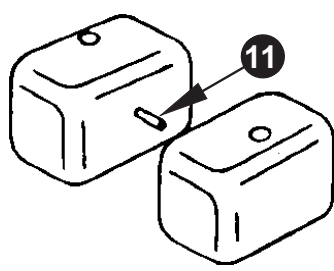
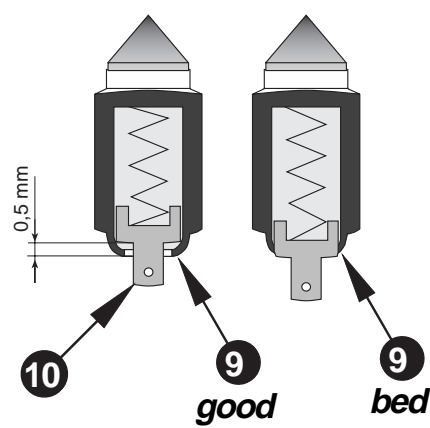
3) Check of float needle:

Examine float valve with float chamber removed. At visible wear of beaded edge **9** at the spring pin **10** the valve has to be renewed. If the distance becomes less than 0,5 mm (see illustration) the float level will be affected too. Check support pin **11** of floats.

At heavy wear of float bracket contact faces, caused by excessive vibration, renew float and float bracket as required.
