**Grounding cable for electronic module of
ROTAX Engine Series Type 912 A**

Subject: Inspection of electronic module on engine series 912 A. Specifically, review cable lug connection onto grounding cable.

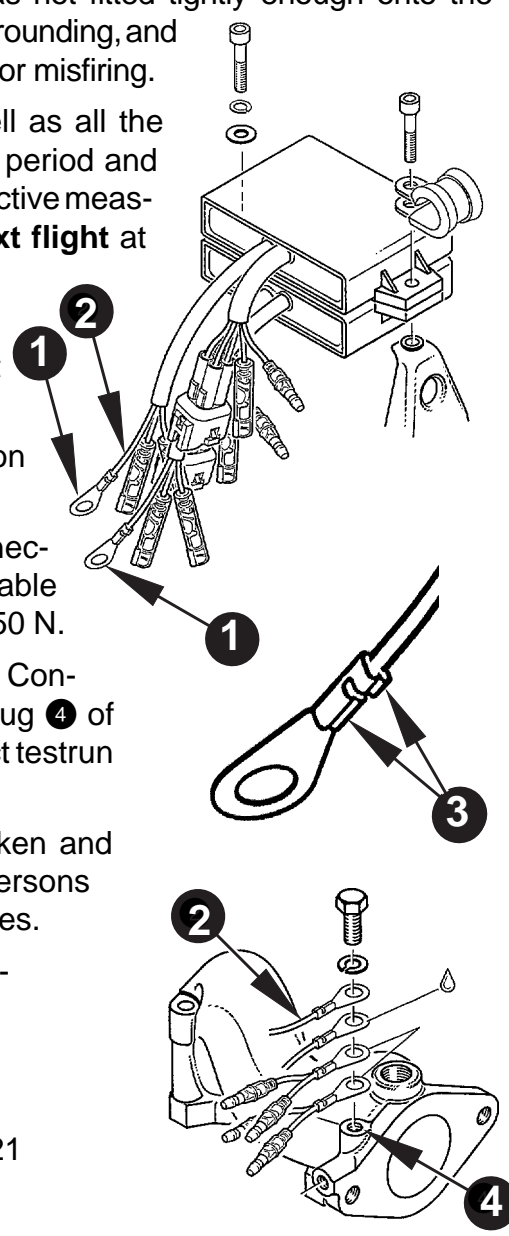
Reason: Production machinery problems may have caused inadequate cable assembly on electronic module, part no. 965 356.

In some cases the cable lug ① was not fitted tightly enough onto the grounding cable ②, resulting in poor grounding, and possibly leading to engine stoppage or misfiring.

Remedy: To guarantee the sufficient crimping ③ of the cable lug a pull-off test with 50 N has to be conducted.

◆ **NOTE:** The specified extraction force is 100 ÷ 200 N.

At occurrence of an inadequate connection, correct by crimping on new cable lug, part no. 964 056 and test with 50 N.

Apply Lithium grease on cable lug. Connect both grounding cables ② on lug ④ of the right intake manifold and conduct testrun and ignition check.
