**Ground connection for pick-up wiring, ROTAX Engine Series Type 912**

**Subject:** Improvement of ground connection for the screening braid of pick-up wiring and charging cable

**Engines affected:** All engines of Series 912 A, beginning with engine no. 4,076.064, since introduction of the SMD-ignition unit.

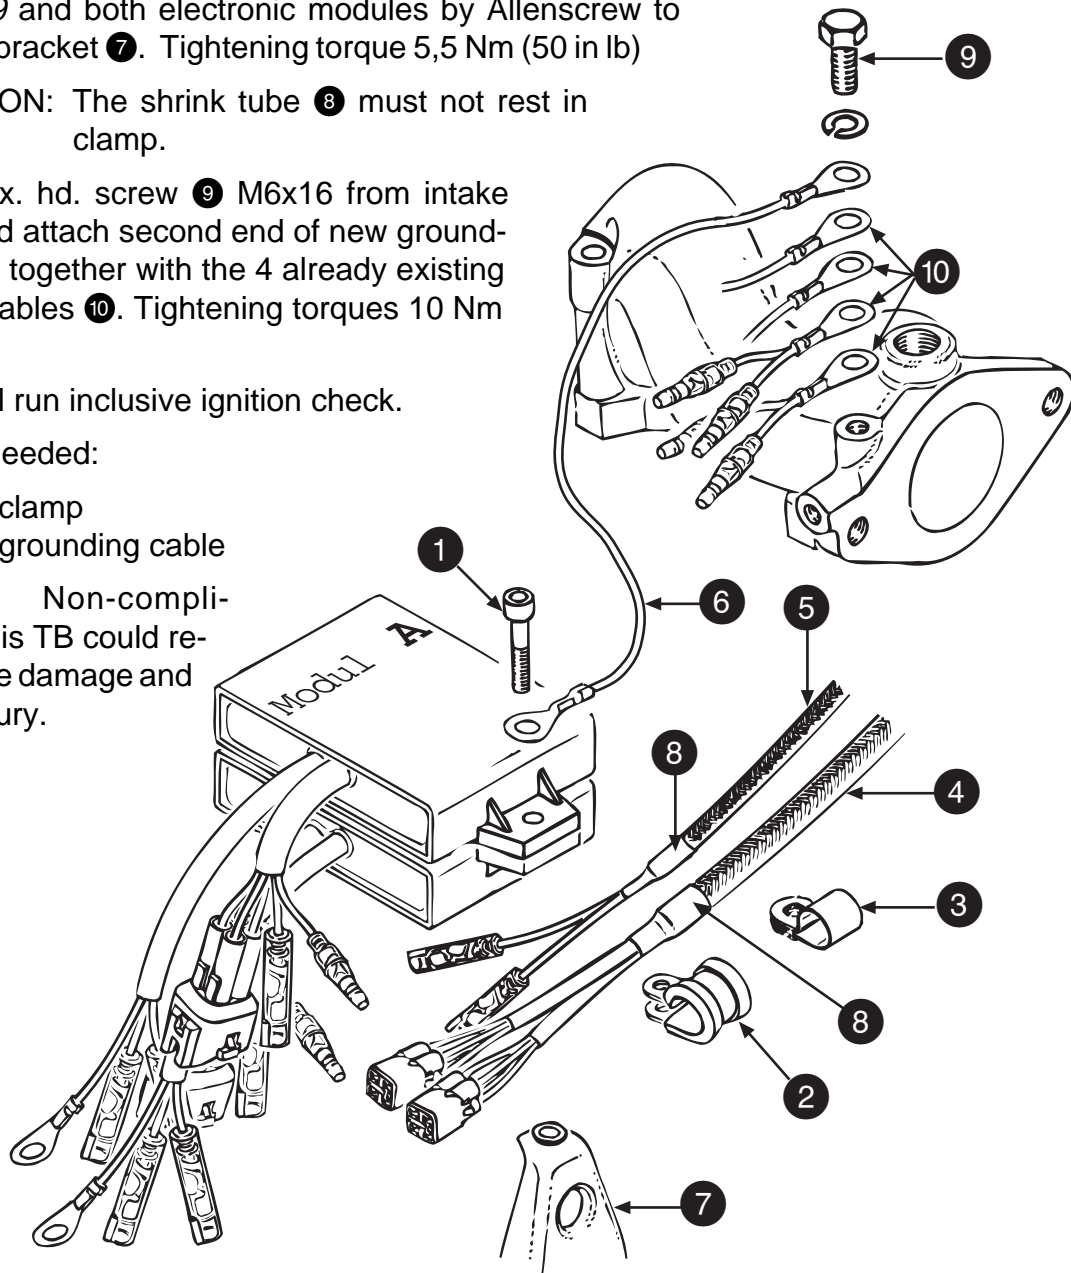
**Reason:** On the current installation of the ignition unit, troubles could occur in areas with heavy radio transmission. Because of the good result of the respective tests for EMC (electro magnetic compatibility) all the engines affected have to be reworked.

- 1) Remove Allen screw ① M5x25 and the clamp ② with rubberlined inside.
- 2) Slide new clamp ③ ( without rubberlining) over the cable-assemblies ④ and ⑤ so far that the screening braid rests completely in the clamp.
- 3) The shorting cables have to be furnished with screening over the complete length. The sceening to be attached via short connection prices on the Allen screw ① together with grounding cable ⑥. On the ignition switch side the screening of the shorting cable has to be securely connected to ground too.
- 4) Attach new grounding cable ⑥ *part-no. 965 787*, clamp ③ *part-no. 851 119* and both electronic modules by Allenscrew to ignition coil bracket ⑦. Tightening torque 5,5 Nm (50 in lb)

■ **ATTENTION:** The shrink tube ⑧ must not rest in clamp.

- 5) Remove hex. hd. screw ⑨ M6x16 from intake manifold and attach second end of new grounding cable ⑥ together with the 4 already existing grounding cables ⑩. Tightening torques 10 Nm (90 in lb)

- 6) Perform trial run inclusive ignition check.
