TBO for ROTAX Engine Series Type 912 A

Mandatory

- Subject:** Increase of TBO from 600h or 10 years to 1000h or 10 years of operation.
- Engines affected:** All engines of Series Type 912 A starting with engine no. 4,076.192 in accordance with Type Certificate TW 8/89.

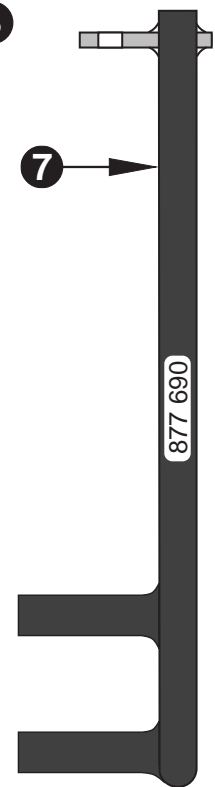
Examine float valve with float chamber removed. At visible wear of beaded edge **9** at the spring pin **10** the valve has to be renewed. If the distance becomes less than 0,5 mm (see illustration) the float level will be affected too. Check support pin **11** of floats.

At heavy wear of float bracket contact faces, caused by excessive vibration, renew float and float bracket as required.
